NASA CR-225

OPERATION OF A HAYNES ALLOY NO. 25 FORCED CIRCULATION
LOOP TO STUDY THE EFFECTS OF HYDROGEN IN A
SIMULATED SUNFLOWER SYSTEM

By R. C. Schulze and D. B. Cooper

Prepared under Contract No. NAS 5-462 by
THOMPSON RAMO WOOLDRIDGE INC.
Cleveland, Ohio

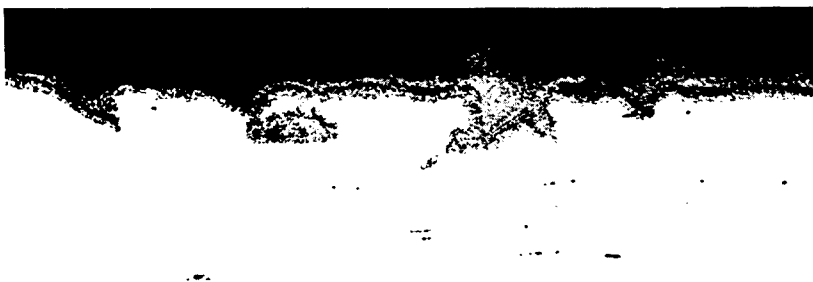
Figure 33. I.D. Surface of Specimen Removed from the Middle Region of the Boiler (Section 12, Thermocouple No. 6).

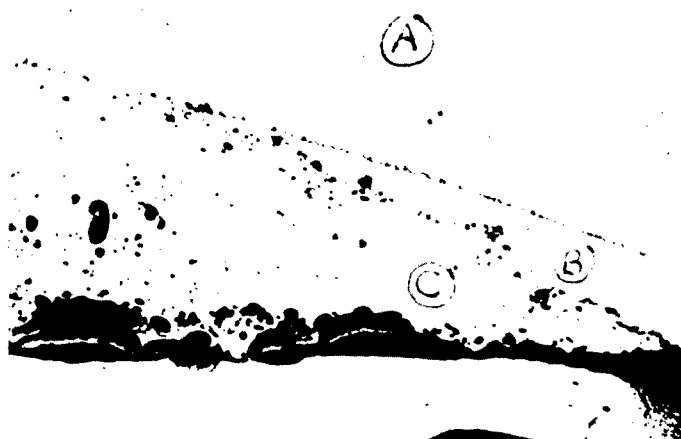
Figure 49. I.D. Surface of the Specimen Removed from Section No. 20A, Thermocouple No. 18, Showing the Areas Analyzed. This area is the area marked by the arrow in Figure 45.

Two areas of different composition were found within the deposit on the specimen Section No. 20A, thermocouple No. 18. As shown in Table 18, the bulk of the deposit (Figure 48 and marked C in Figure 49) was predominantly nickel with about 25 to 27 percent chromium. Only minor amounts of tungsten, iron and cobalt were found. However, another phase, (marked B in Figure 29) was found that was almost pure chromium (98-99 percent). Cobalt, tungsten, iron and nickel were found only in small or trace amounts. The results of the analysis of the specimen Section No. 22, thermocouple No. 21 were approximately the same. However, the chromium-rich phase was present in a greater quantity within the deposit. Also, there was not the same amount of distinction between the phases as was found in the specimen Section No. 20A, thermocouple No. 18.

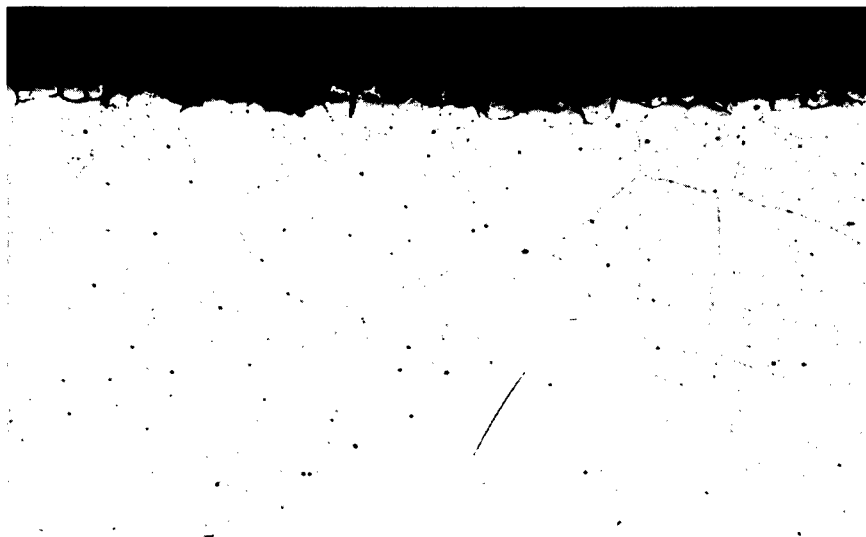
Figure 59 shows the general appearance of the crack in the tube wall. As can be seen, the crack is intergranular in nature. Also, along the crack, smaller cracks were found extending into the grain boundaries from the failed surface. The mode of failure appears to be a brittle type of fracture.

Figure 59. Appearance of the Crack Found in the Tube Wall of the Superheater After 262 Hours of Operation.
